Case Study

TRITON PRODUCTS REPLACE FAILED SYSTEM

Triton TT Super barrier coating and Platon Double Drain membrane were used as part of an ingenious design to replace an existing waterproofing system which had failed.

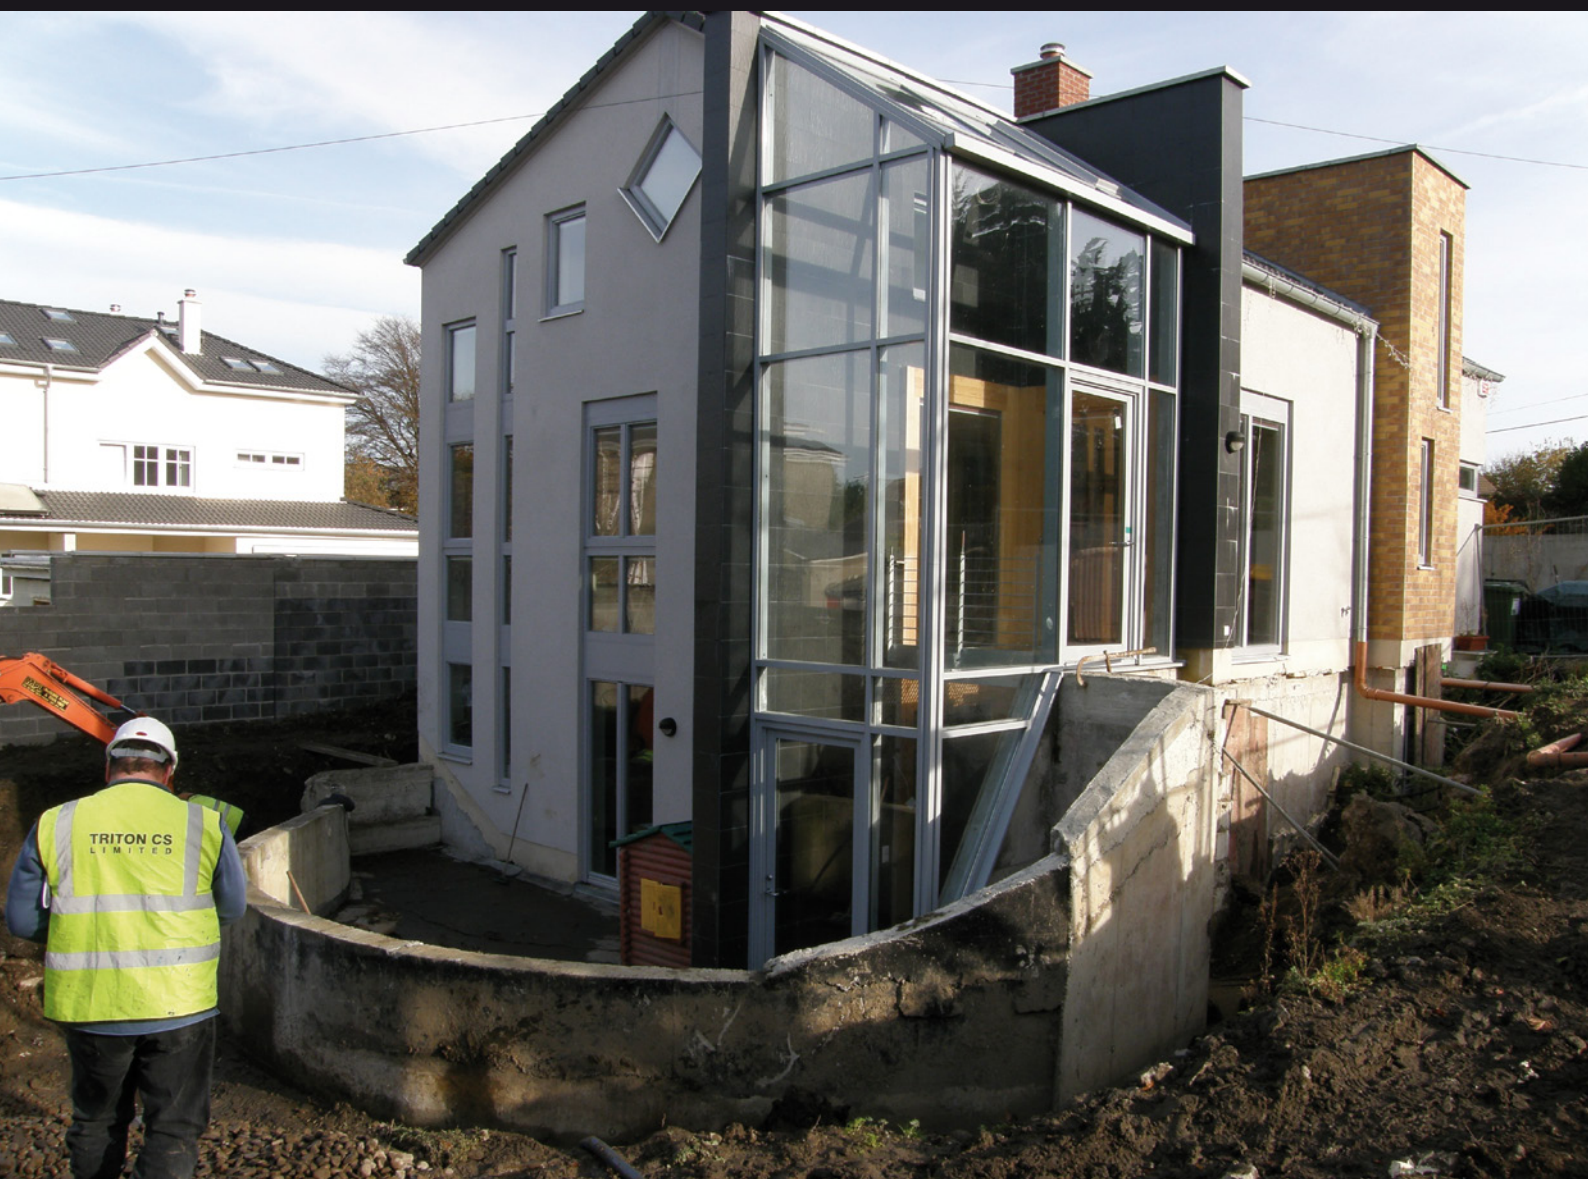
Designed by Cork based Triton Conservation Systems, the system was installed at a new residential property after a water bar detail had failed at the floor/wall junction and the mass concrete walls at basement level were also weeping due to failure of the waterproof concrete.

The exposed wall areas below ground were stripped back to the original mass concrete and pressure cleaned. They were then coated with three coats of TT Super before the installation of Double Drain Membrane.

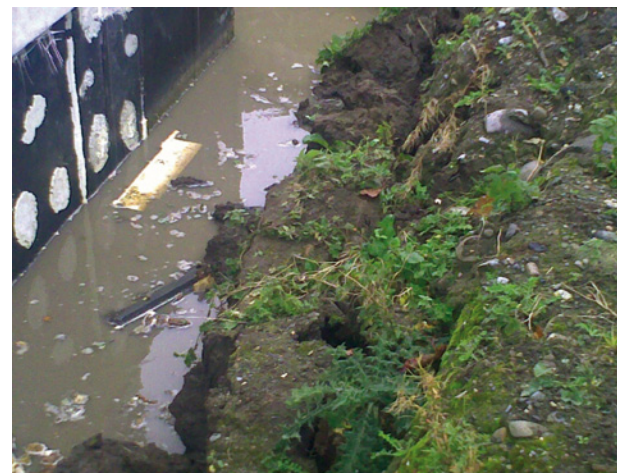
Areas of collapse prior to commencement

The works were essential as the site had become unsafe and the back filling around the property was collapsing and being washed away underground through an old river bed. The rainwater collection tank was also leaking as the ground had collapsed underneath it and opened up all the pipe work.

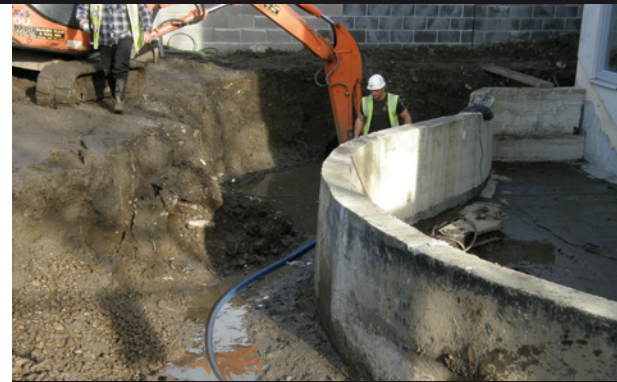
Excavation works in progress

Triton Conservation Systems excavated around the entire property below the raft foundation so as to drop the water table and remove around 900 tons of material before replacing with a safe back filling designed to compact properly.

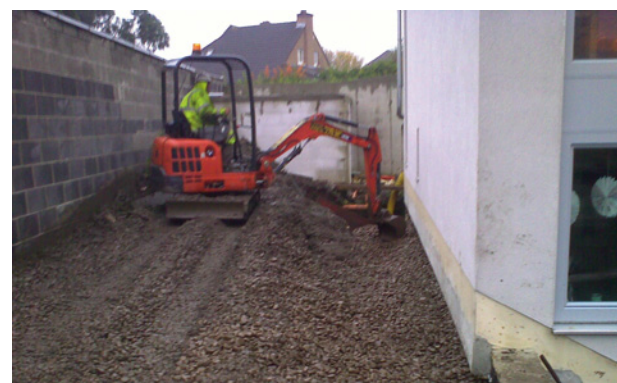
New back filling

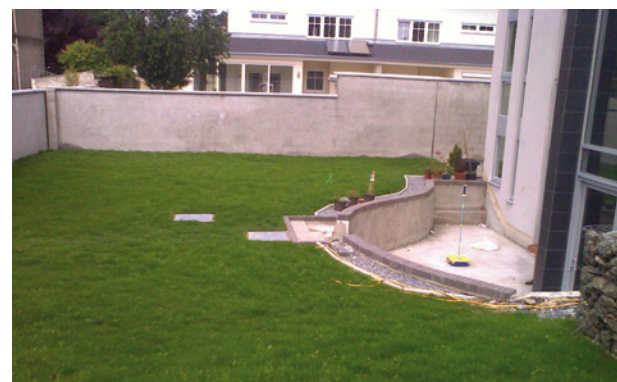
Works completed and property landscaped
