### A CARING APPROACH TO TIMBER PRESERVATION

Conservation & Restoration Projects used timber preservation treatments from Triton to preserve the timbers at St Mary's Church, Crosserlough in County Cavan, Ireland.

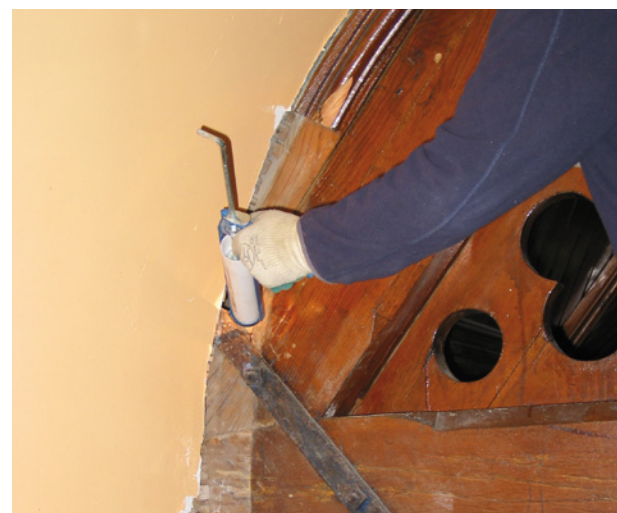
*The main truss ends being injected with Tribor Gel which was also used on the wall plates*

JH Projects specified Triton's Tribor Gel to control and prevent further wet rot attack. Tribor Gel is a ready to use glycol-Borate formulation which penetrates deeply into timber, and remains within the timber for the long term. It is supplied in easy to use cartridges and applied to the timber via pre-drilled holes. A total of around 1500 holes were predrilled into the timbers, where required, before injection with Tribor Gel. Pitch pine plugs were then cut and fitted flush to the original timber surface and stained to match the existing finish of the exposed decorative trusses.

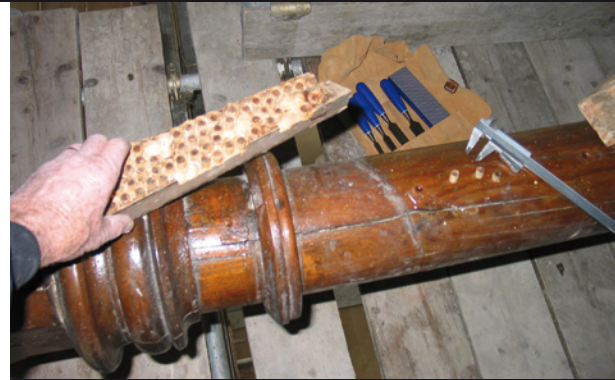
*Preparation of 10mm pitch pine plugs for restoring drilled surface of exposed and ornate timbers injected with Tribor Gel*

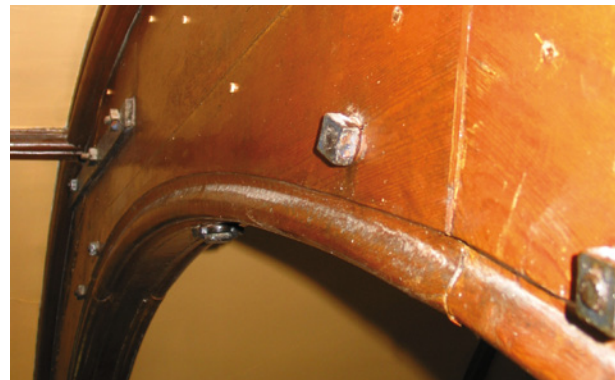
*The pitch pine plugs were inserted by hand (standing slightly proud in photo) before being hammered flush with timber and stained*

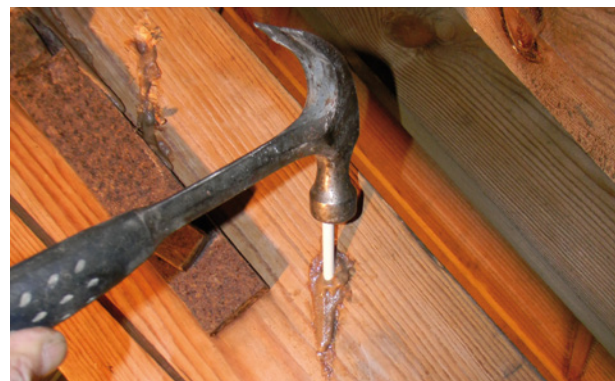
*Trimol 50 rods (set in Trimol 36 grout) were hammered in to stitch shakes in main roof trusses*

Additional timber repairs were undertaken using Trimol 50 rods and Trimol 36 structural grout.

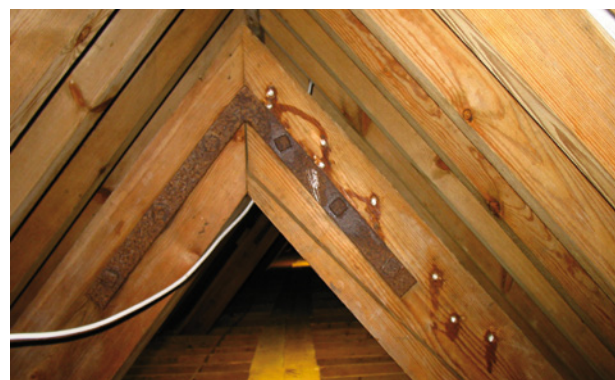
*The rods were then cut flush with the timber surface*
