MEMBRANES MEAN FASTER REINSTATEMENT FOLLOWING FLOOD

Flood remediation systems from Triton Chemicals helped minimise the time taken to reinstate a terraced property after flooding; and allowed the owner to move back many months earlier than her neighbours.

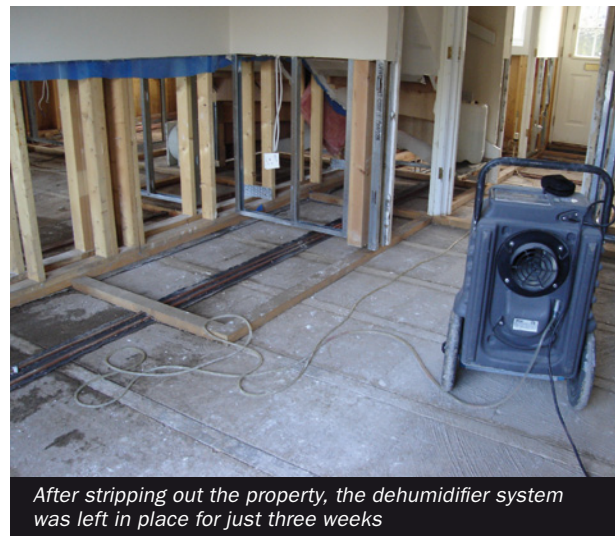
After stripping out the property, the dehumidifier system was left in place for just three weeks

Stripping out started immediately to remove the plaster up to a metre high, the fibreglass insulation from the cavity walls, the chipboard floors and PE membranes and insulation. Every remaining surface was then power washed and sprayed with a sanitiser. The dehumidifier system was then left in place for three weeks.

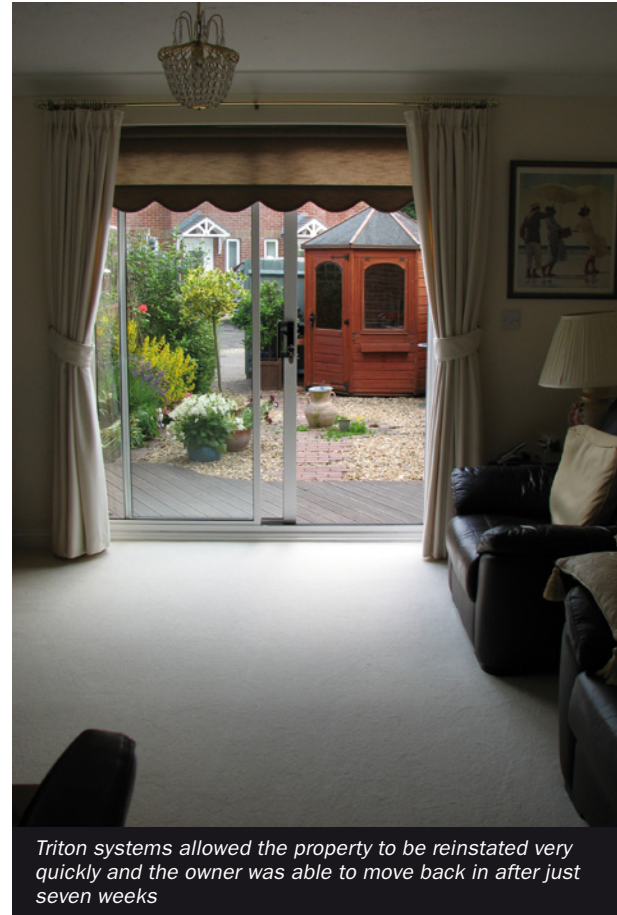
Triton systems allowed the property to be reinstated very quickly and the owner was able to move back in after just seven weeks

During week four, Triton's Platon Stop cavity drain membrane was laid to the concrete floor up to the physical DPCs at the base of the timber frame. New insulation and a chipboard floating floor was then installed. The bottom of the partition walls were reinstated, new plaster board fitted and walls skimmed from floor to ceiling.
